Reconstructing Timber Swing Bridges at Parks Canada

Robert W. Passfield

This article traces the reconstruction of four timber swing bridges by Parks Canada in the period 1978–1986. It sets forth the two different approaches that were followed in reconstructing and upgrading the evolved form of the historic timber swing bridges on the Rideau Canal; identifies and examines the several departures introduced during the four reconstruction projects; and elaborates on the efficacy of “ekki” hardwood in facilitating a highly accurate reconstruction of three of those heritage bridges.

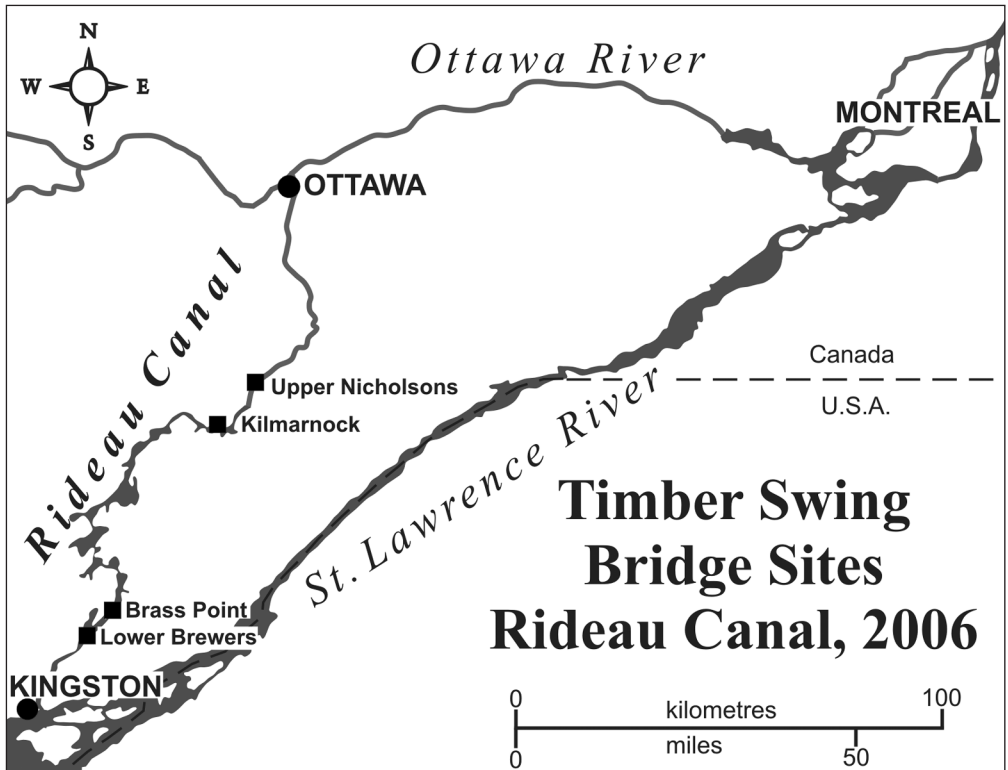
The four timber swing bridges extant on the Rideau Canal today were reconstructed by Parks Canada at Brass Point (December 1978), Lower Brewer's (June 1984), Upper Nicholson's (March 1986), and Kilmarnock (May 1986). (K. Watson, 2006)

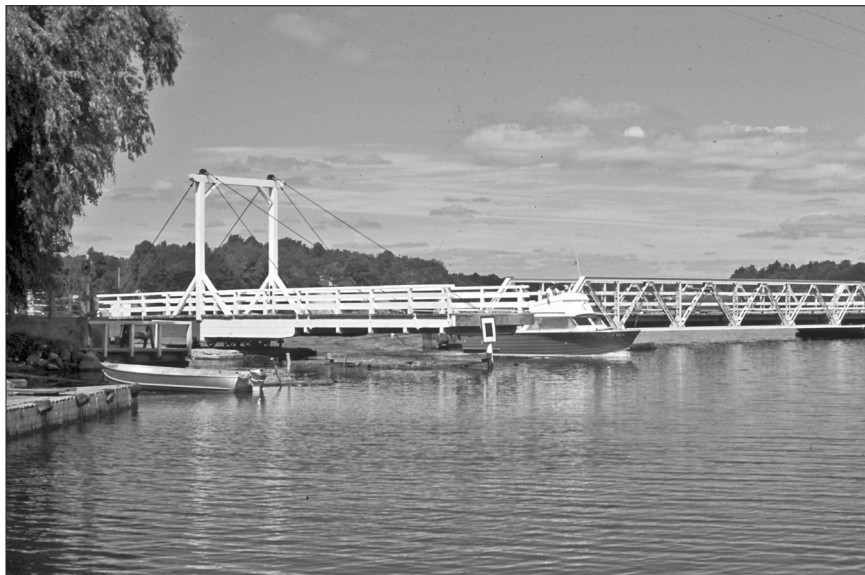
Figure 1. Brass Point Swing Bridge, Rideau Canal, showing the extant swing span reconstructed in 1964 by a canal carpentry crew. (Photo by author, July 1974)

At Brass Point, there was a low-level, multi-span bridge structure of 467' length overall that carried a county road across a 30' deep arm of Cranberry Lake on a river section of the Rideau Canal. The bridge consisted of a timber swing bridge of 72'-6" span, last reconstructed in 1964, and four riveted steel truss fixed spans of a Warren pony truss configuration, dating from 1903. The steel spans had a 16' width (15' clear roadway) and a 6-ton highway loading capacity, whereas the timber swing bridge had a 12' width (11' clear roadway) and a 5-ton highway loading capacity when new. (Figure 1)

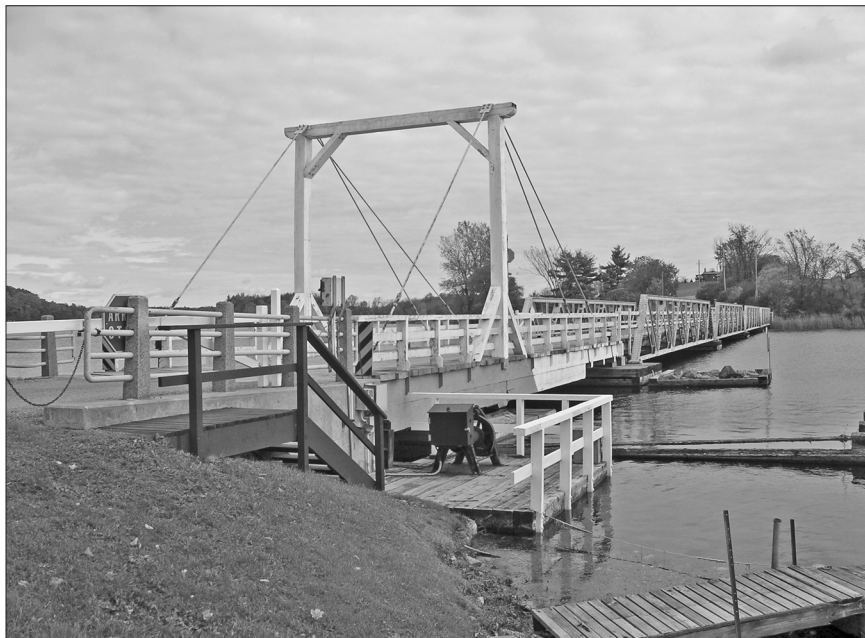
Figure 3. Brass Point Swing Bridge, showing the swing span crossing as reconstructed by Parks Canada in 1978. (Photo by author, October 2006).

The working plans were prepared by Canal Engineering Division, Architecture & Engineering Branch, Parks Canada, and the swing span was reconstructed under contract by the Dineen Roads and Bridges Co. Ltd. of Rexdale, Ontario, in October 1977. The reconstructed Brass Point timber swing span and the four steel-truss replacement spans were completed as of December 1978.¹⁰ (Figure 3)

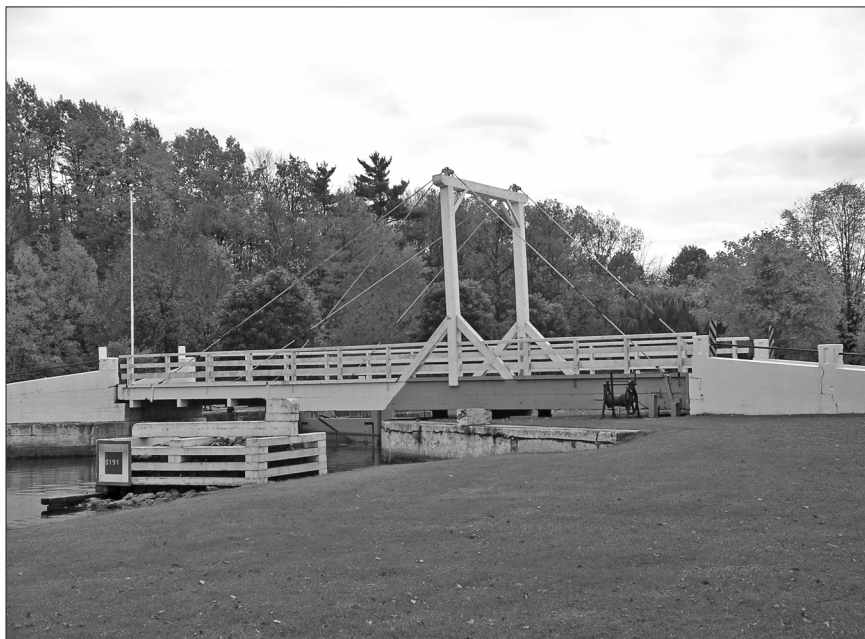
Figure 6. Lower Brewer's swing bridge, showing the swing span reconstructed by Parks Canada in 1984. (Photo by author, October 2006)

In mid-June the completed bridge was hoisted onto the pivot pier, with a Linkbelt 3-axle Zephyr crane of 30 tonnes lifting capacity. Given the increased weight of the ekki members, some steel ballast had to be substituted for rock ballast to properly balance the swing structure, but otherwise no problems were experienced. On June 26, 1984, the bridge was accepted by Parks Canada and placed in service.³⁶ (Figure 6)

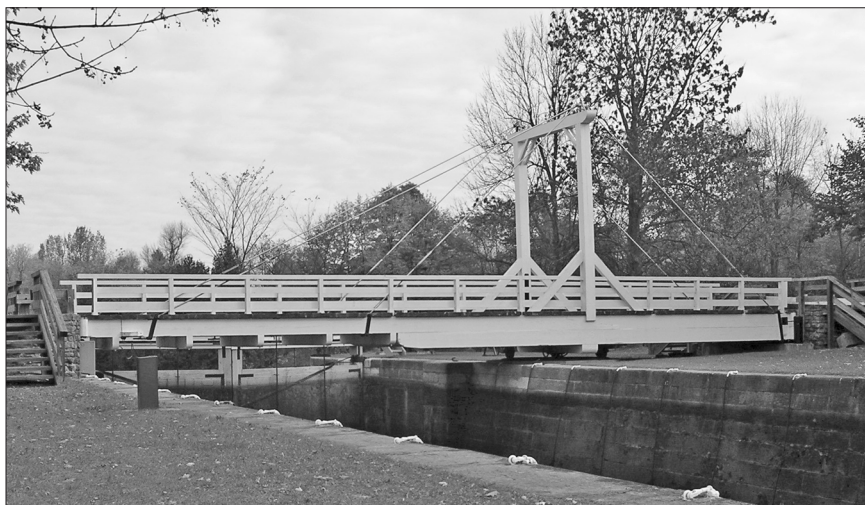
Figure 8. Upper Nicholson's swing bridge, as reconstructed by Parks Canada in 1986. (Photo by author, October 2006)

In at least two respects, the Upper Nicholson's swing bridge reconstruction was more accurate than the earlier Parks Canada reconstructions. Six ekki floor beams were placed on the long arm of the swing span, thereby matching the number and spacing of the Douglas fir floor beams on the former Upper Nichol-

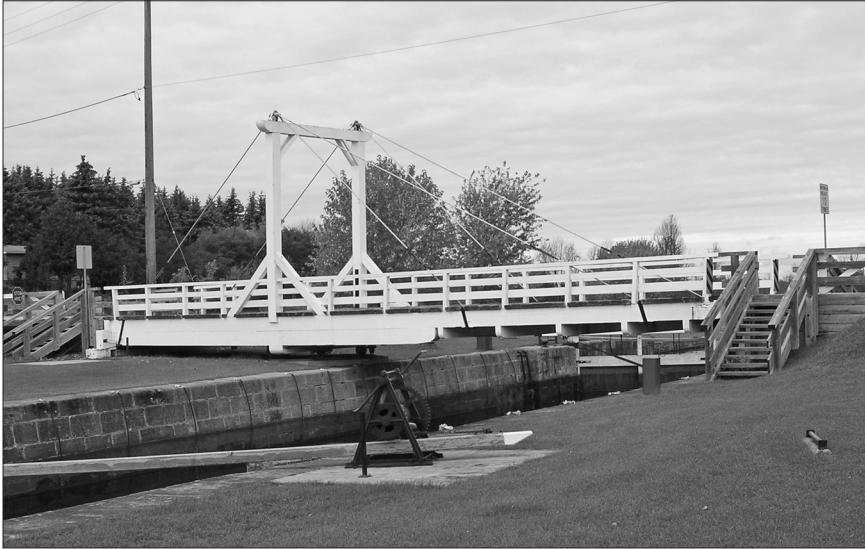
Figure 9. Kilmarnock swing bridge, as reconstructed by Parks Canada in 1986.
(Photo by author, October 2006)

The reconstructed swing bridge was painted in keeping with the same paint specifications as the previous Parks Canada reconstructions. The woodwork and metalwork was painted white throughout to match the demolished structure. The unequal arm swing span was then balanced through adding additional ballast, and the stay rods were post-tensioned. On May 26, 1986, the newly reconstructed and upgraded Kilmarnock timber swing bridge was inspected; accepted by Parks Canada; and opened for traffic.⁴⁰ (Figure 9)
